# Water Pollution Abatement Plan Modification (WPAP Mod)

AC Tejas Quarry  
22845 Old Nacogdoches Rd  
New Braunfels, Texas 78132  
Comal County

Date: August 2023  
Project No. 10603-189  
-NMS-

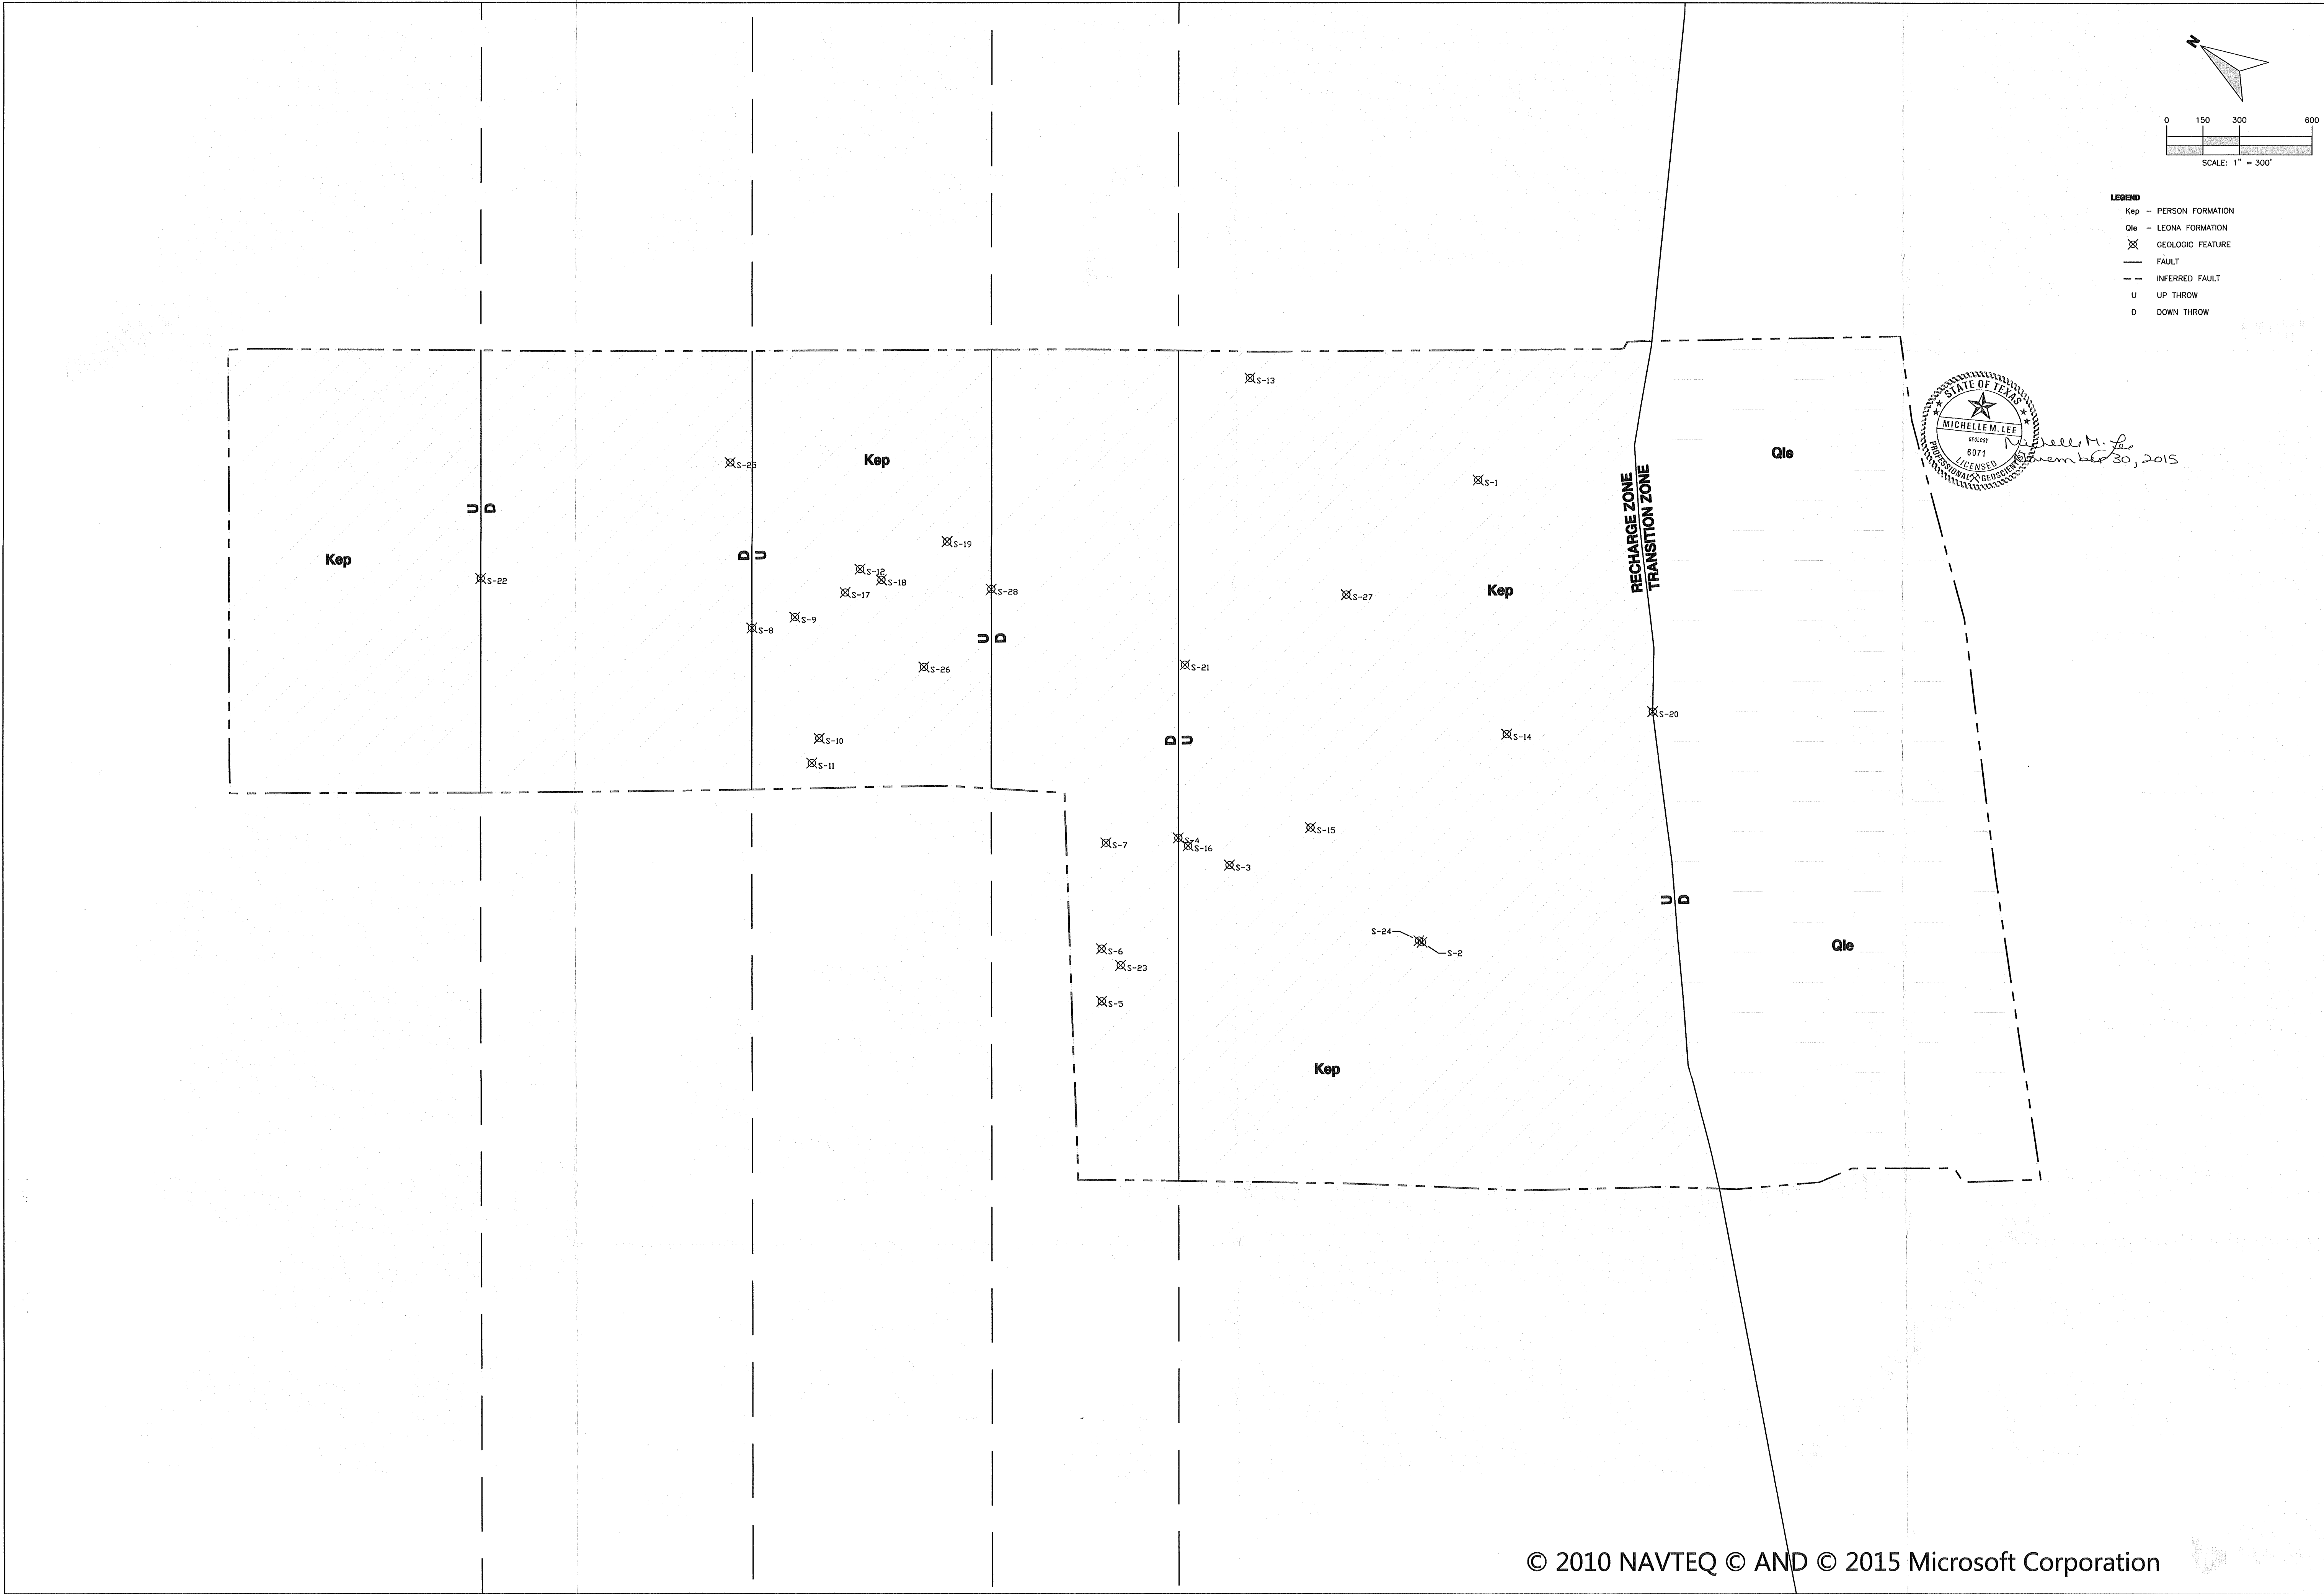
**GEOLOGY MAP**  
ANDERSON COLUMBIA PROPERTY  
ANDERSON COLUMBIA CO., INC.  
FM 1337, NEW BRAUNFELS, TEXAS

- LEGEND**
- Kep - PERSON FORMATION
  - Qle - LEONA FORMATION
  - X - GEOLOGIC FEATURE
  - - FAULT
  - - - INFERRED FAULT
  - U - UP THROW
  - D - DOWN THROW

Five (5) faults were mapped at the site. However only three of the five were visually observed in the field. The large amount of clearing that has occurred at the site has significantly obscured the natural ground surface. The mapped faults were verified with

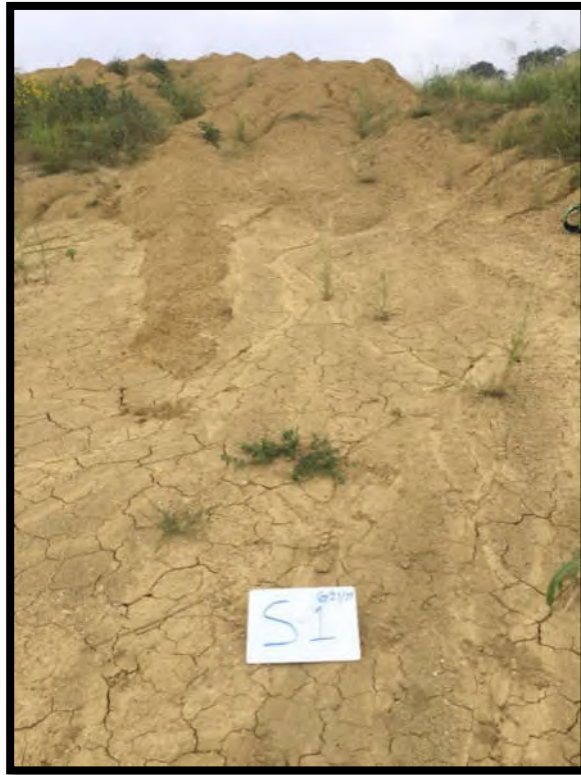
Feature S-1: Floor of closed depression on the southern part of the Site with exposed Kdr.

S-1 is a small solution cavity located on a hillside in the southern portion of the site. 0.3” in diameter and depth, it has fine-grained sediment infill. Relative infiltration rate (RIR) is low.

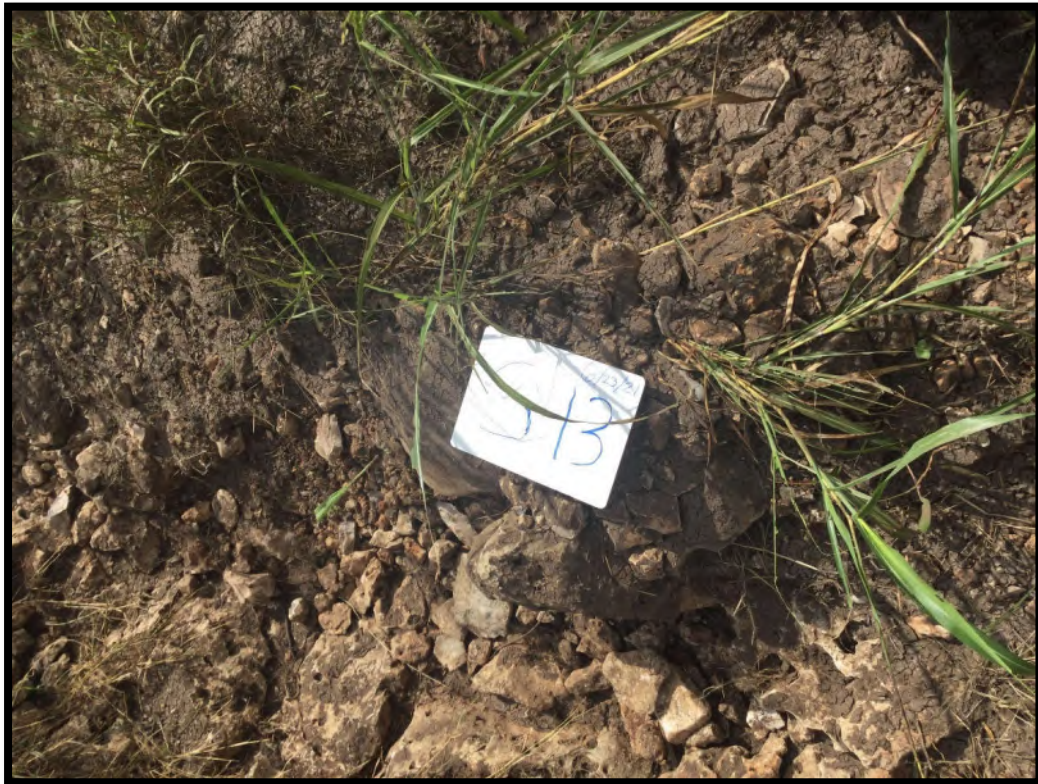
Feature S-13: View of feature floor.

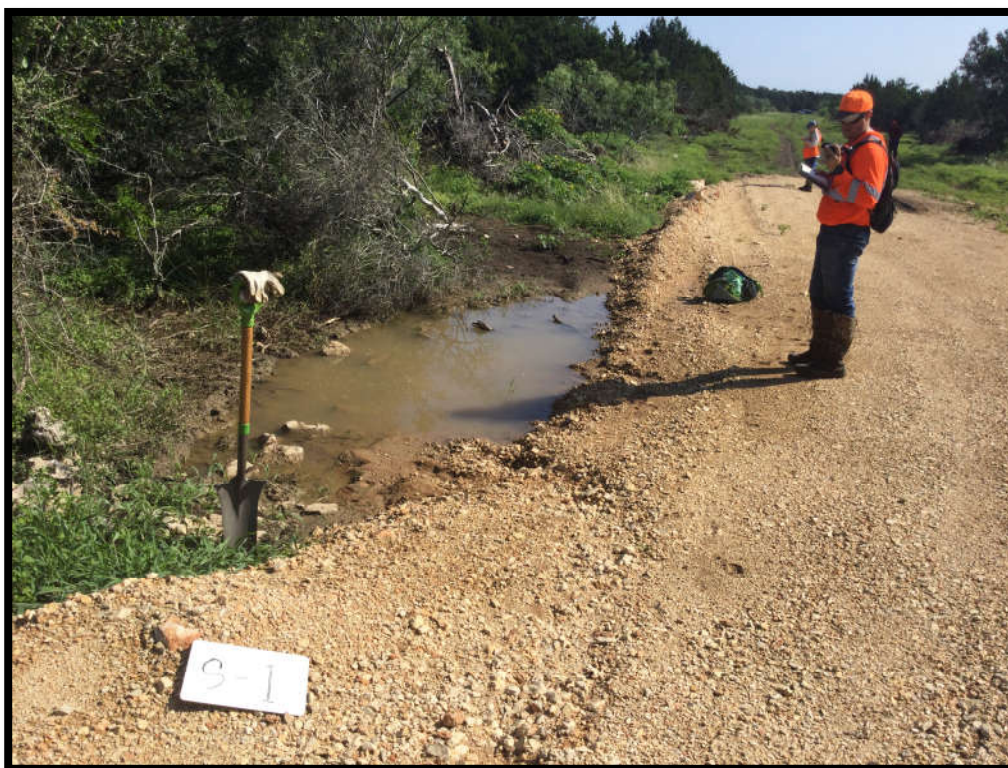
S-1: Closed depression near the entrance of the Site.

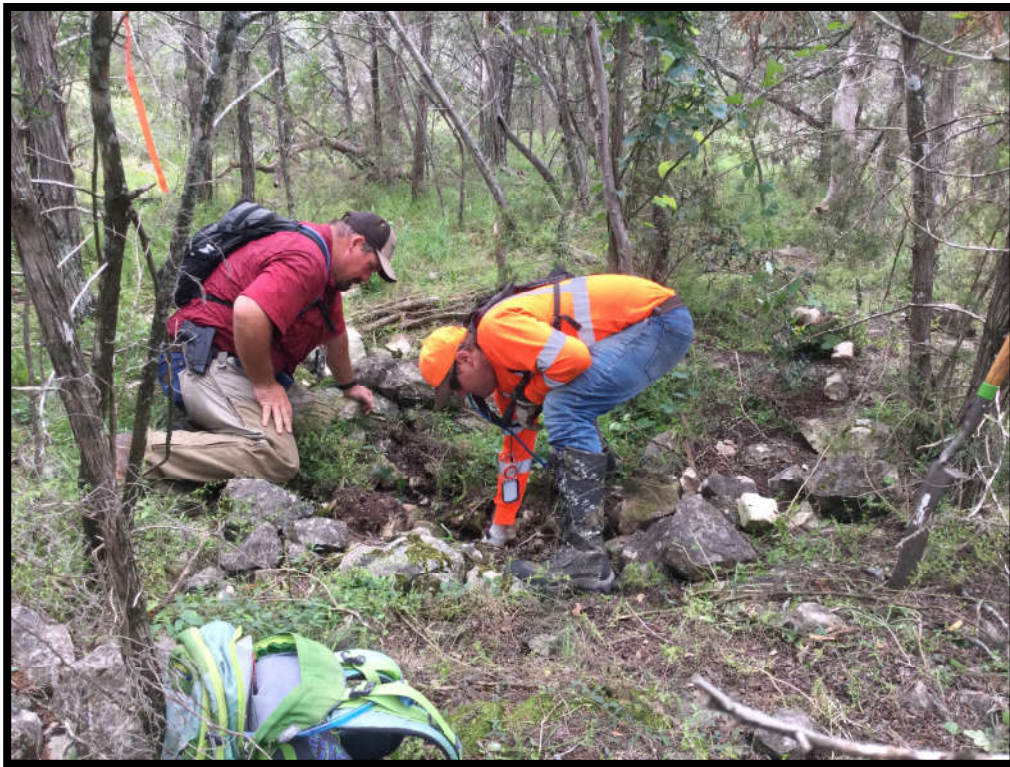
S-27: Hand excavation of loose cobbles of one of the sinkholes that make up this zone feature.

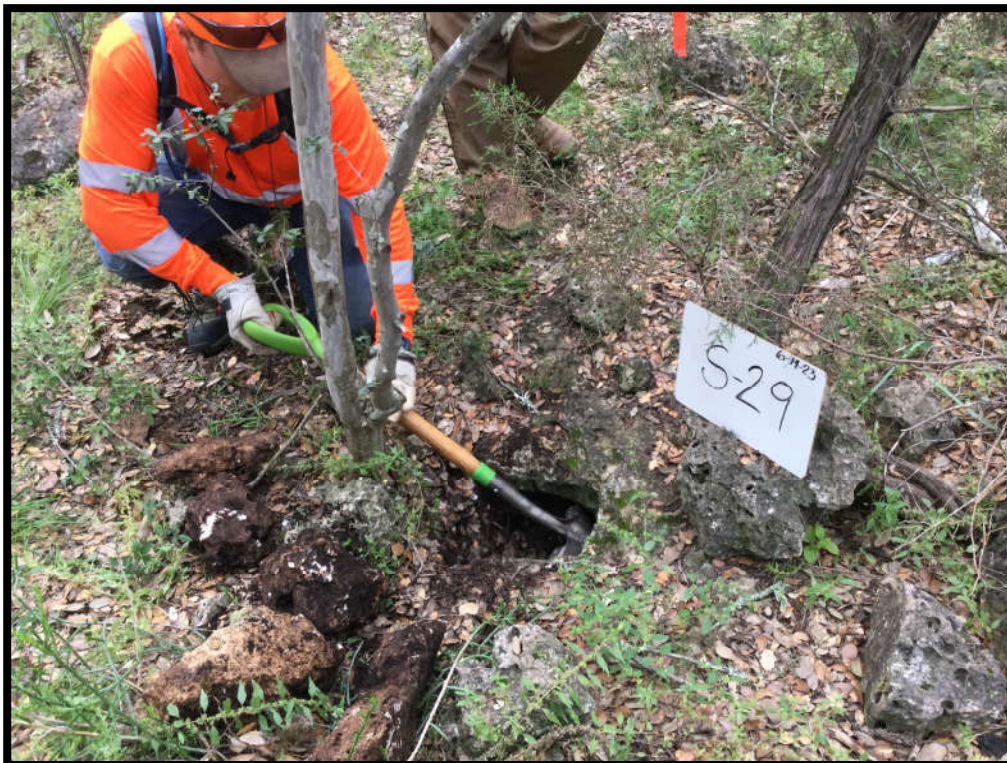
S-29: Hand excavation of one of the solution cavities that make up this zone feature.

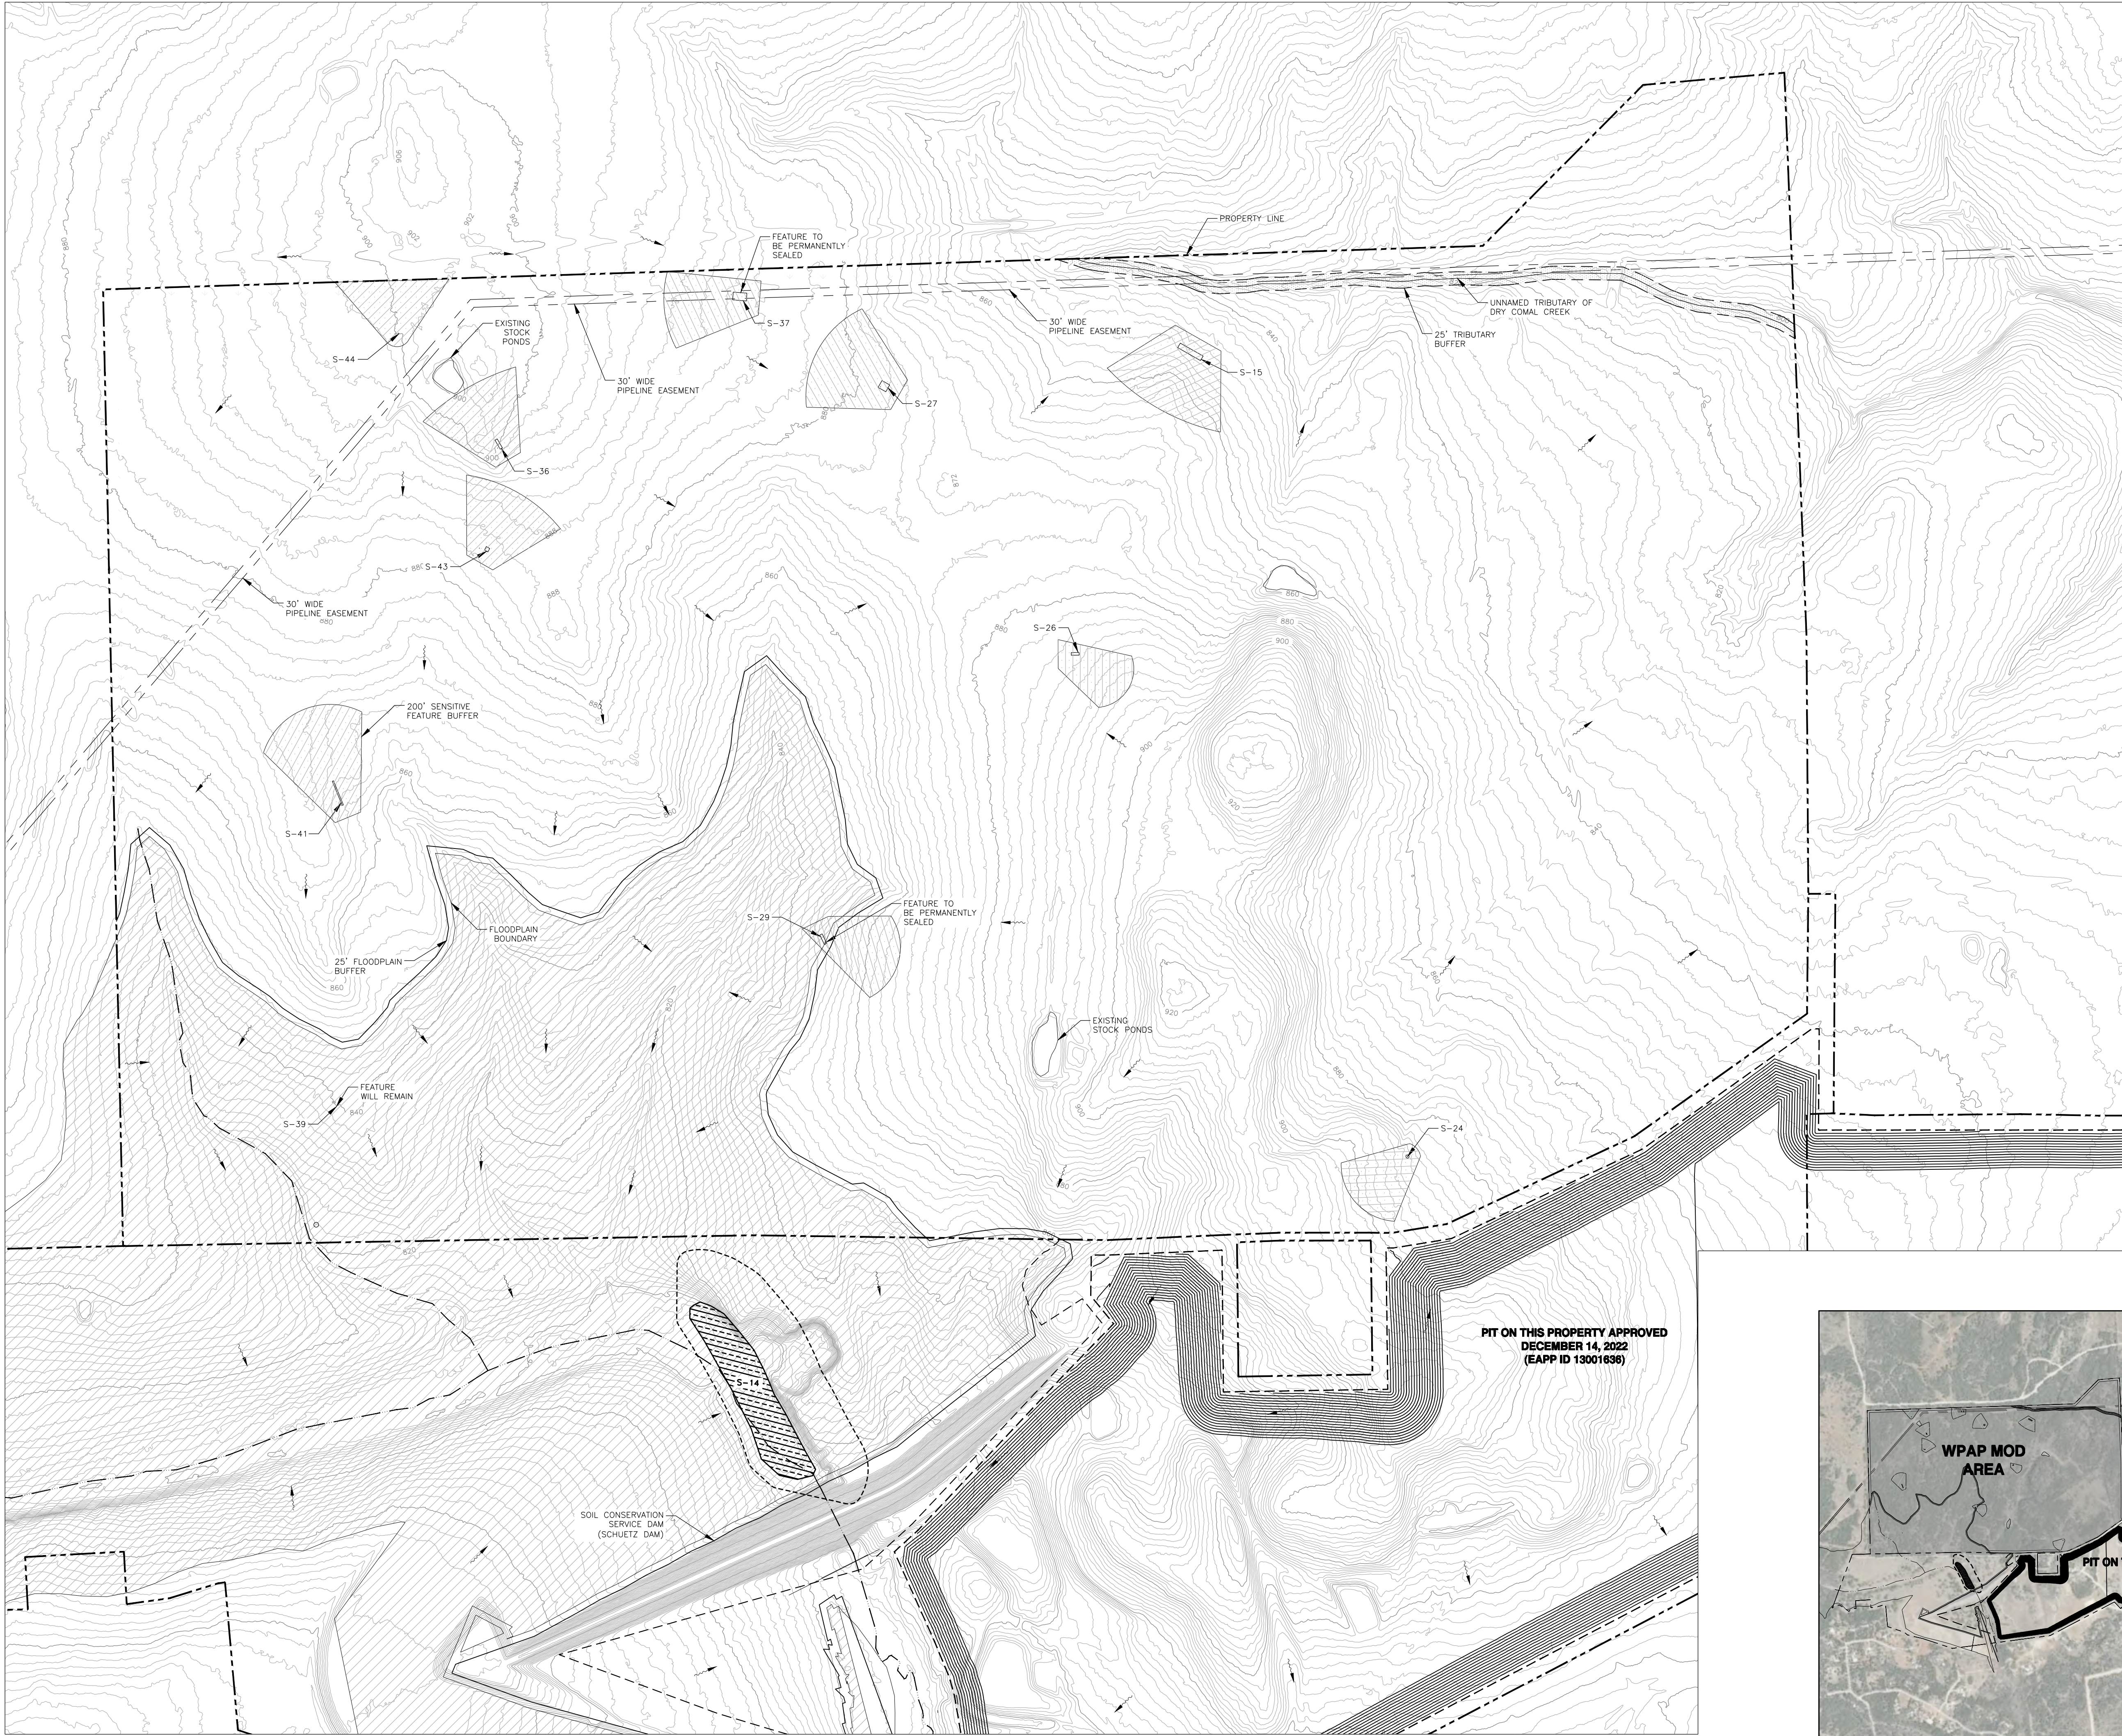
**INTERIM CONDITIONS MAP**  
WPAP MODIFICATION  
ANDERSON COLUMBIA, INC.  
AC TEJAS QUARRY

Please attached Sheet C3 (Interim Conditions Map)

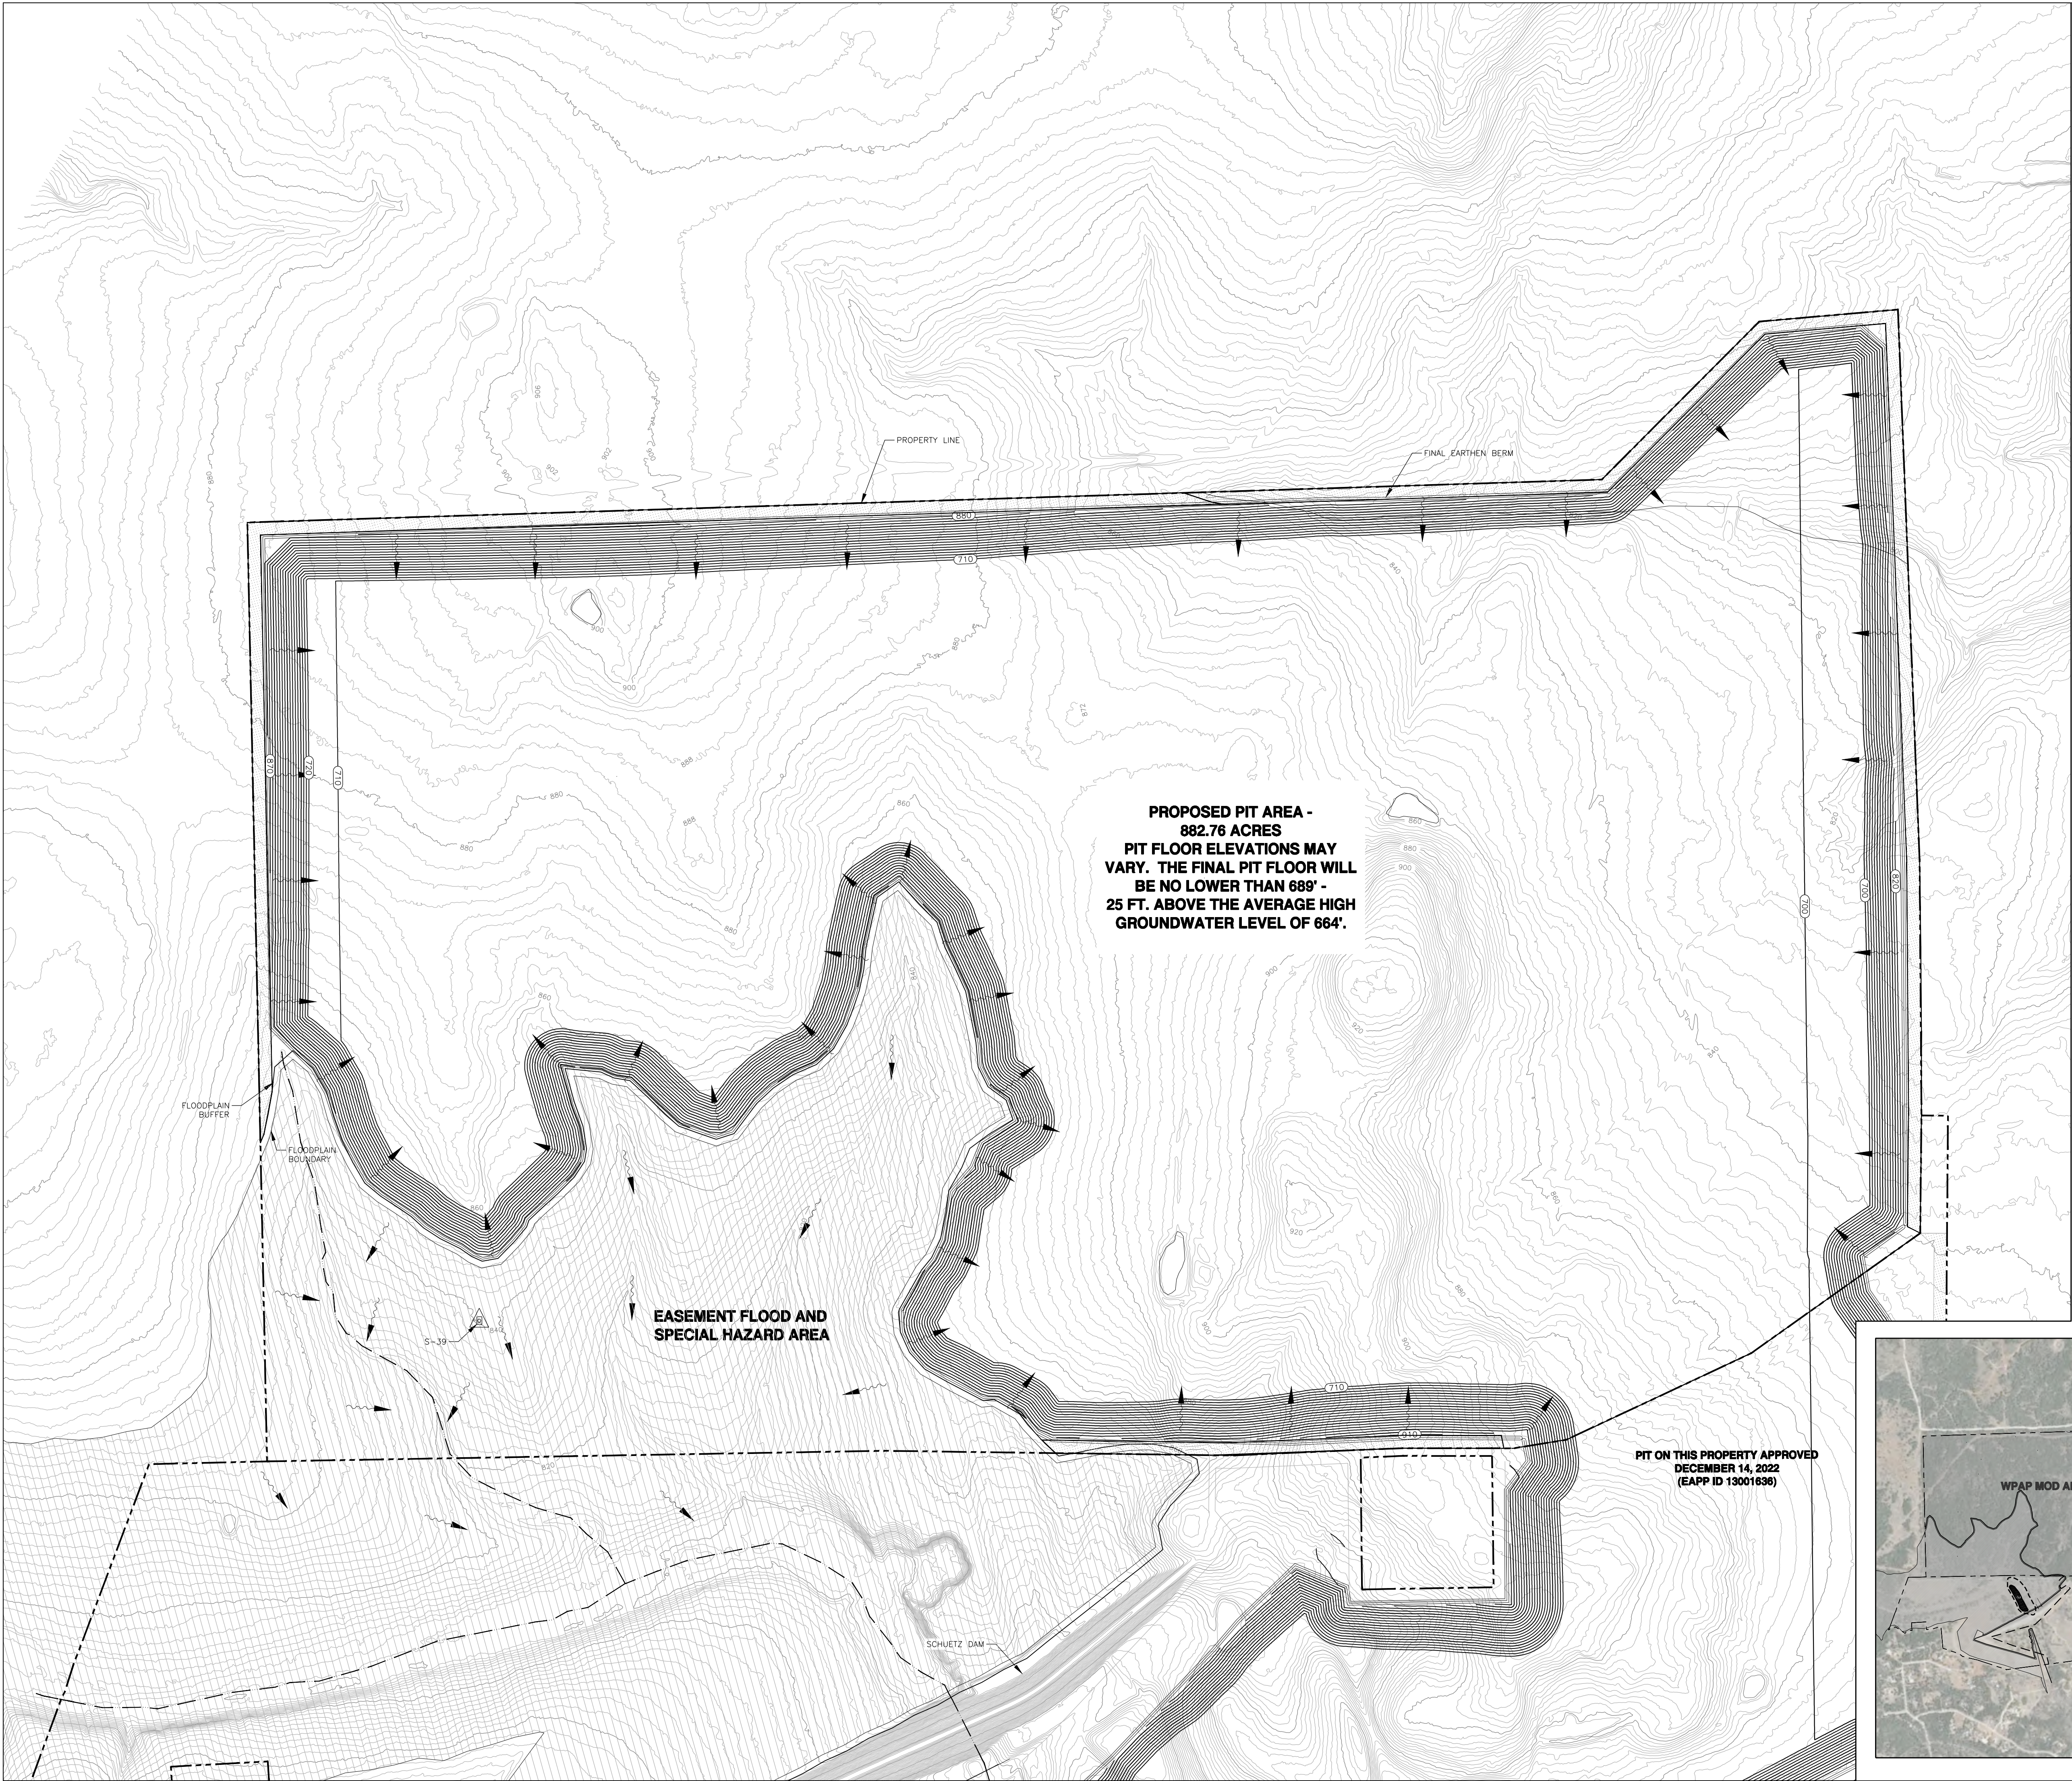
**PROPOSED CONDITIONS MAP**  
WPAP MODIFICATION  
ANDERSON COLUMBIA CO., INC.  
AC TEJAS QUARRY

Please see attached Proposed Conditions Map (Sheet C4) for the final pit layout of the site.

The area being added will be used to further expand quarry operations in the future. The quarry pit may be backfilled with clean fill materials and non-sellable overburden. As quarry operations expand, areas of more than 10-acres of common drainage may be disturbed at a time, however these areas will be contained within temporary earthen berms, which will expand with the operation up to the Final Earthen Berm (as shown on the Proposed Conditions Map), and all run-off from these areas will remain contained on-site, ultimately draining to the pit. An initial phase of mining may involve grubbing a shallow area inside the temporary earthen berms for use as a material storage/staging yard. Within these areas, temporary material stockpiles & temporary compacted base access roads, constituting up to approximately 50-acres of impervious cover, may be established and/or relocated as needed. Runoff from this temporary impervious cover will be treated by surrounding natural vegetation and contained on-site by the surrounding temporary earthen berm (as described above and shown on the Proposed Conditions Map). These areas of disturbance and temporary impervious cover will all ultimately be mined out as the quarry pit expands to its final limits, as shown on the Proposed Conditions Map. The final quarry area is expected to encompass about 883 acres.

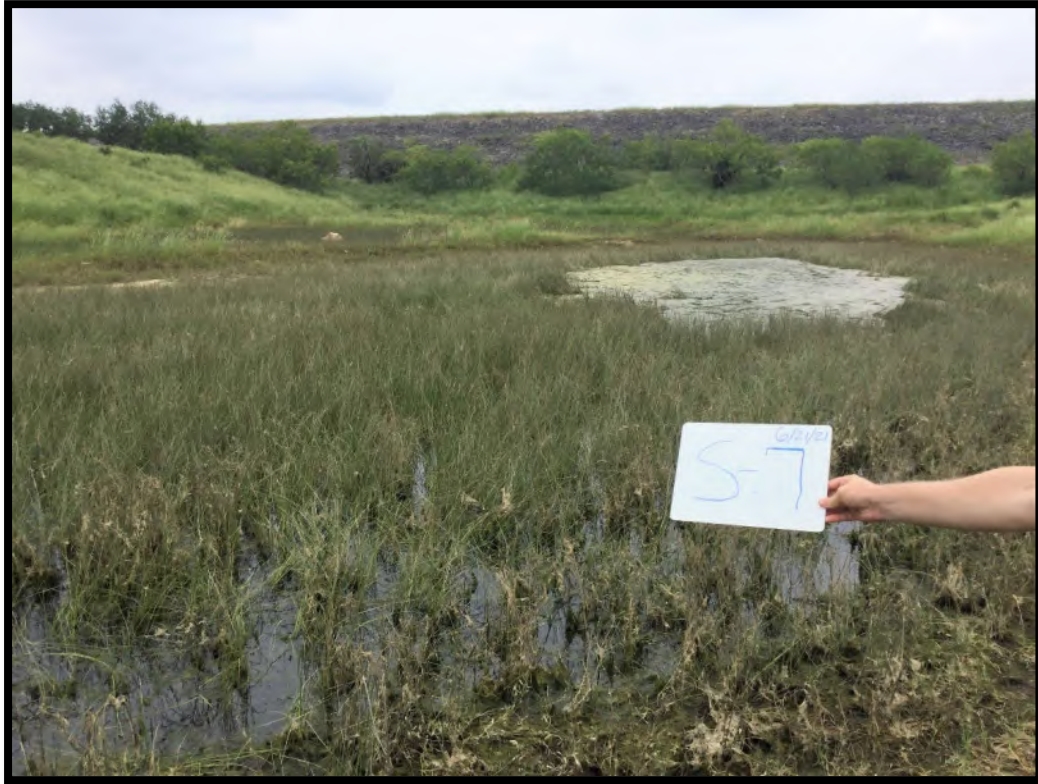
Feature S-7: Closed depression located to along fault S-23.

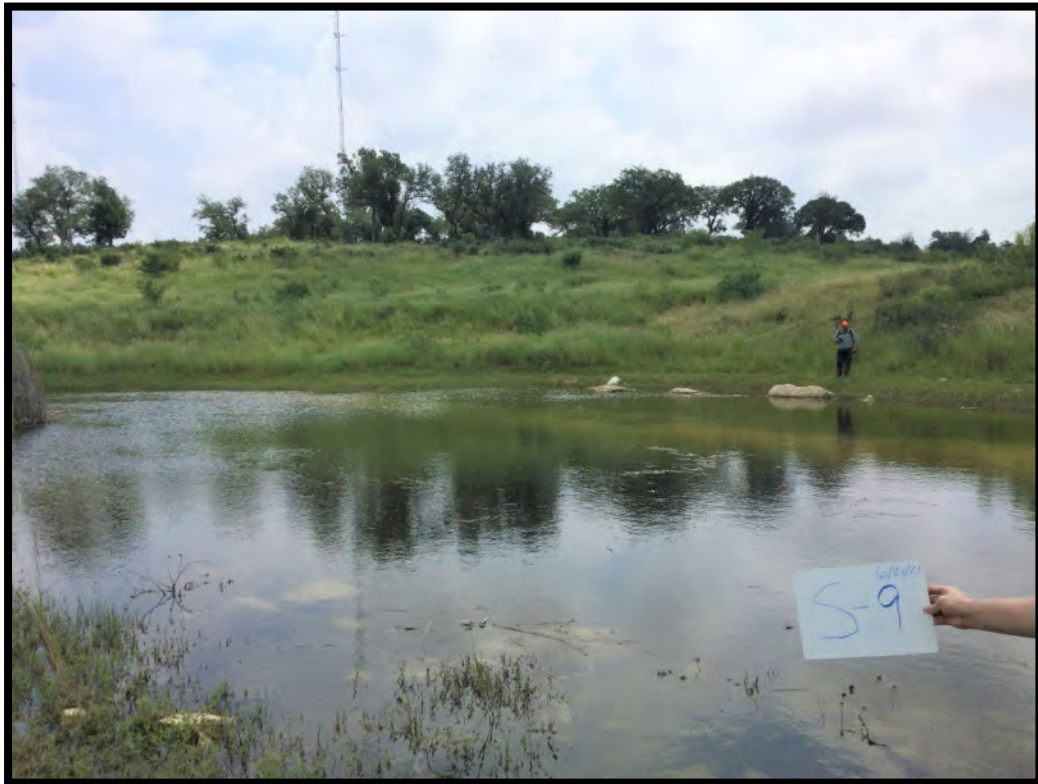
Feature S-9: Closed depression on the south-central part of the Site.

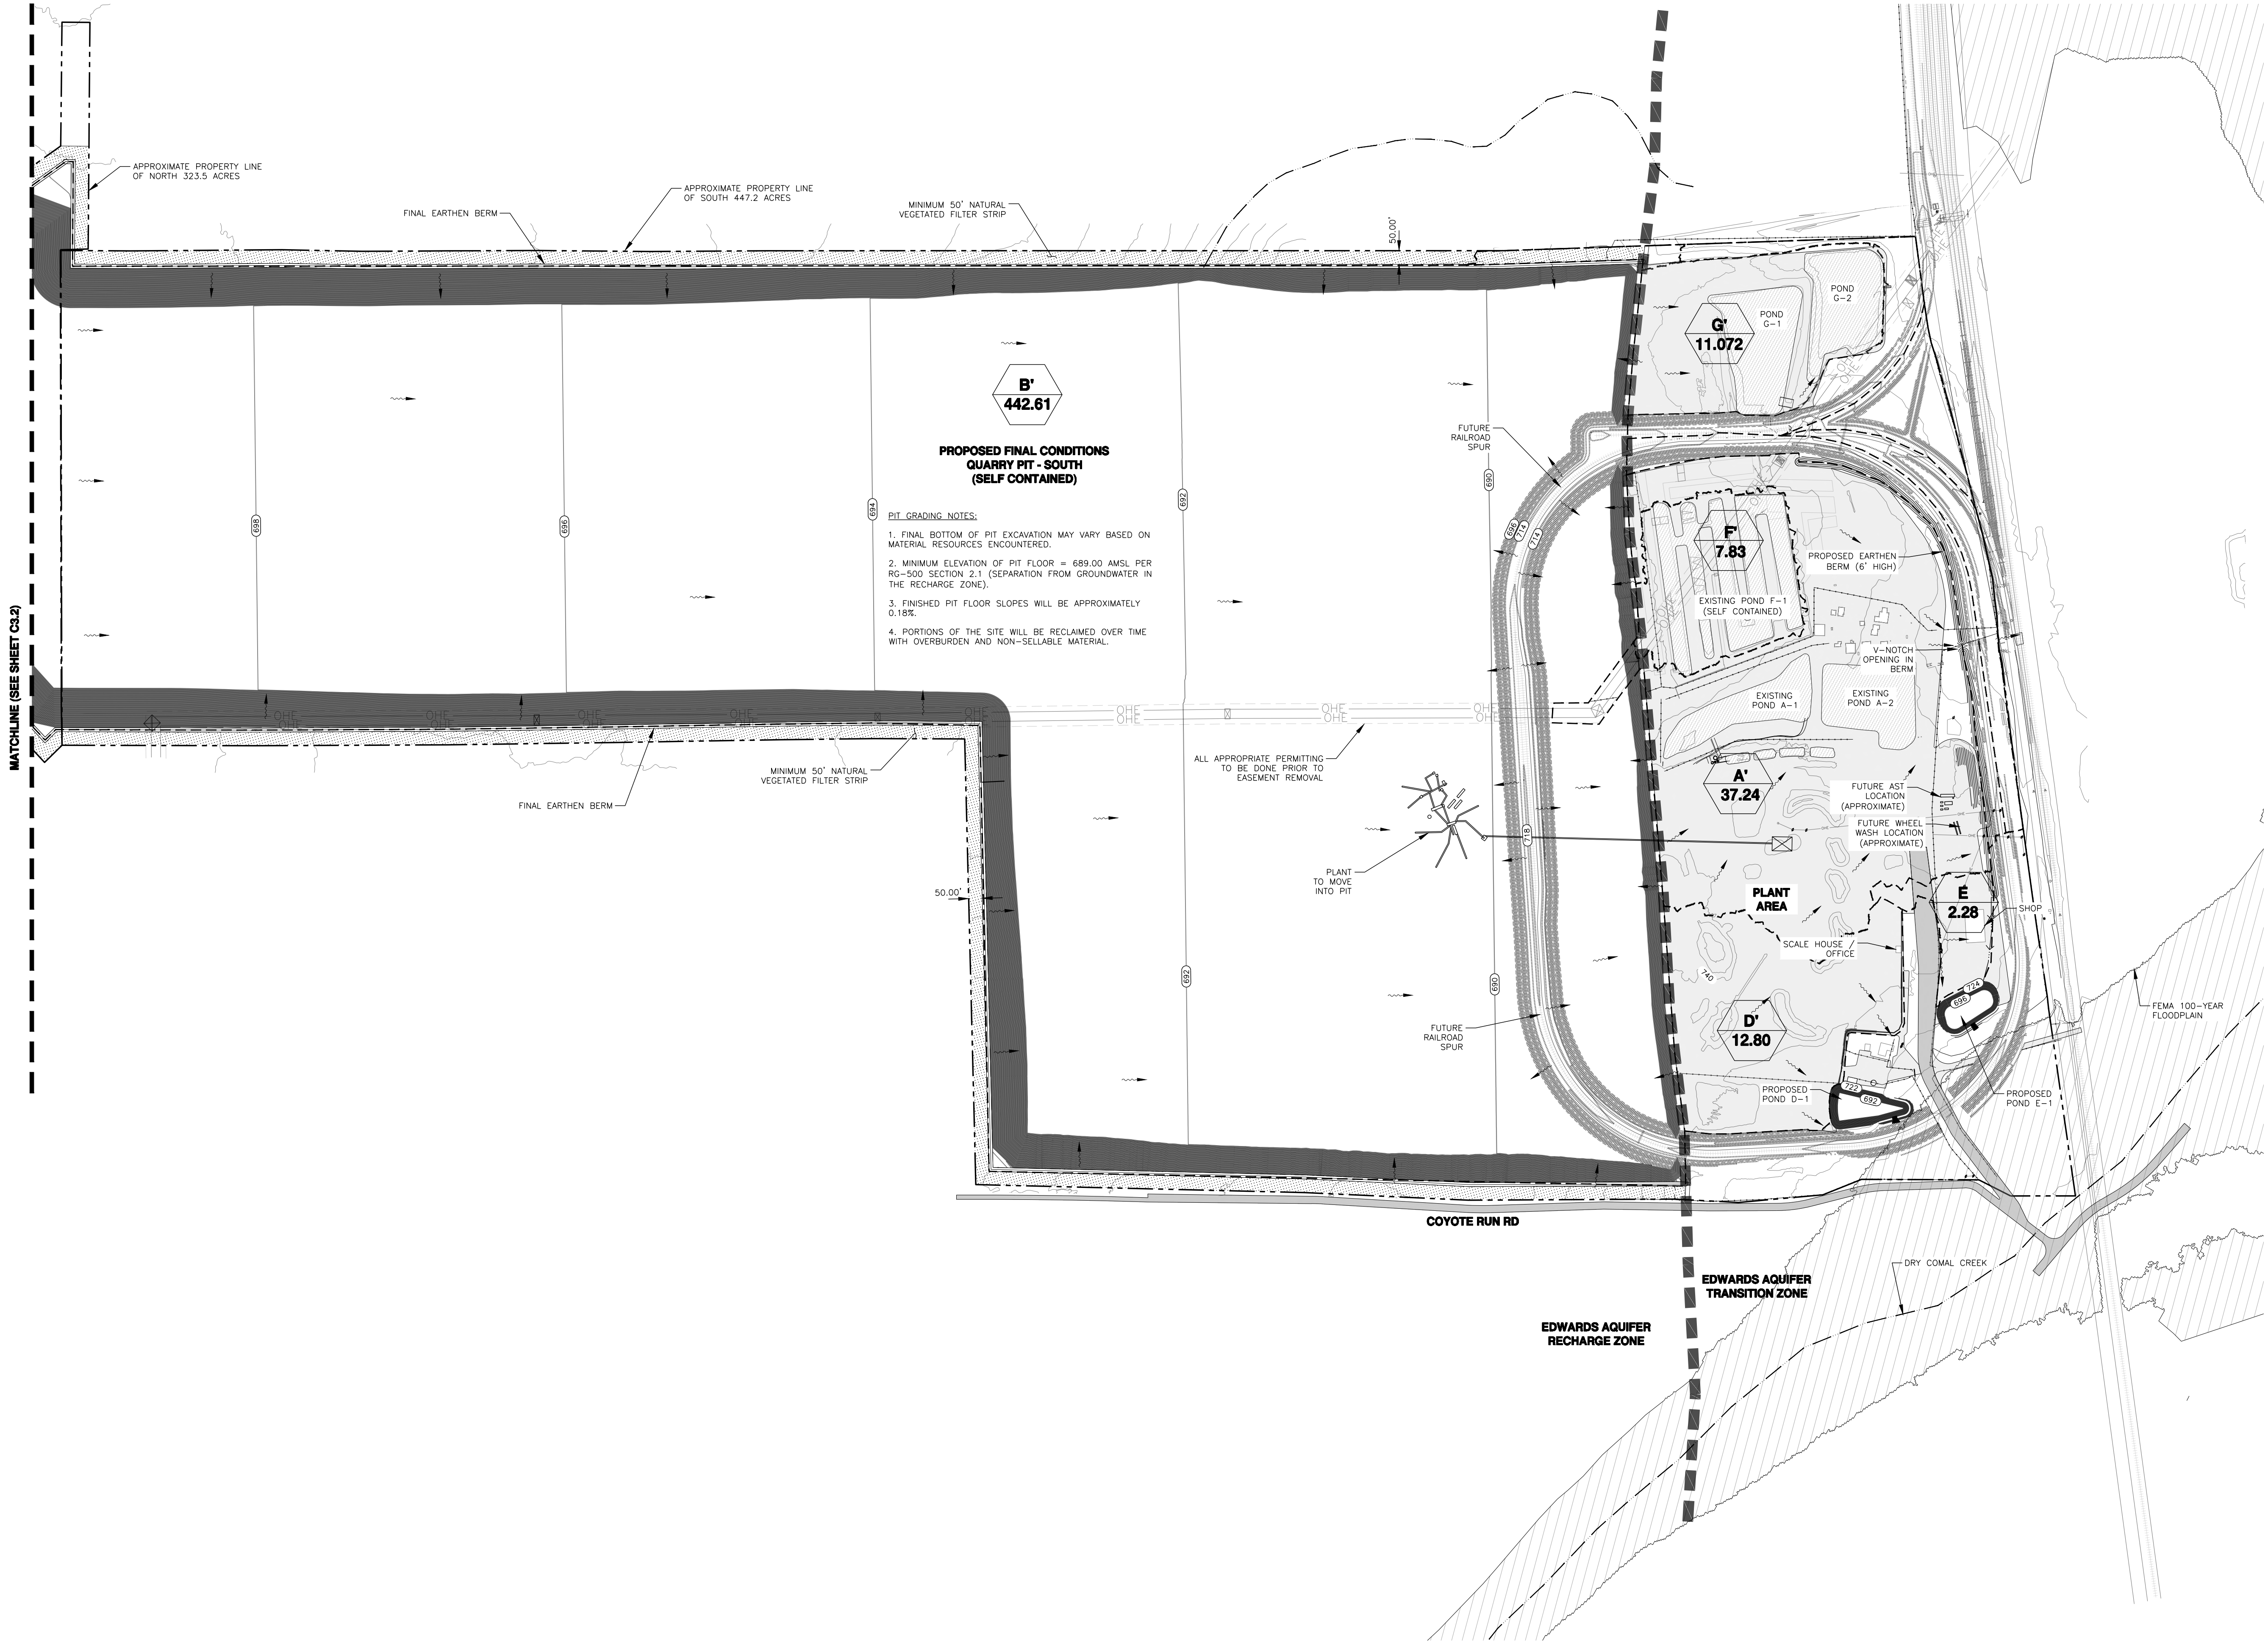
**PROPOSED CONDITIONS MAP SOUTH**  
WPAP MODIFICATION  
ANDERSON COLUMBIA CO., INC.  
AC TEJAS QUARRY

Please see attached Proposed Conditions Map South (Sheet C3.1) for the final pit layout of the southern tract. Proposed Conditions Map North (Sheet C3.2) shows the final pit layout of the norther tract.

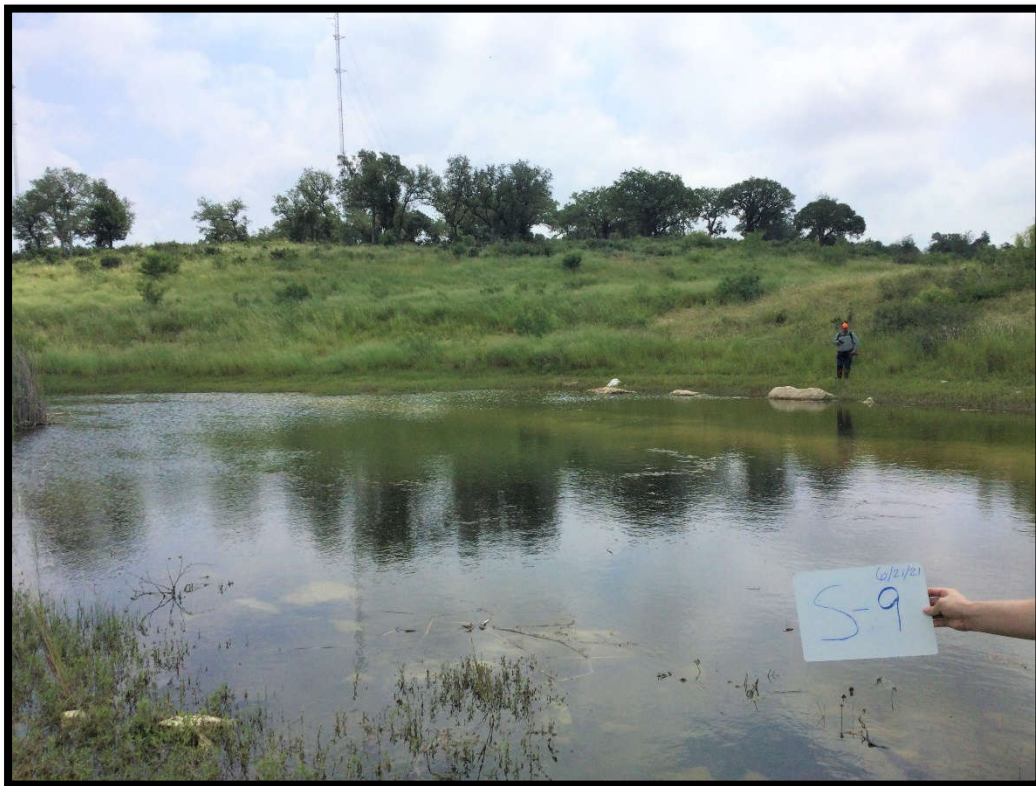
Feature S-9: Closed depression on the south-central part of the Site.

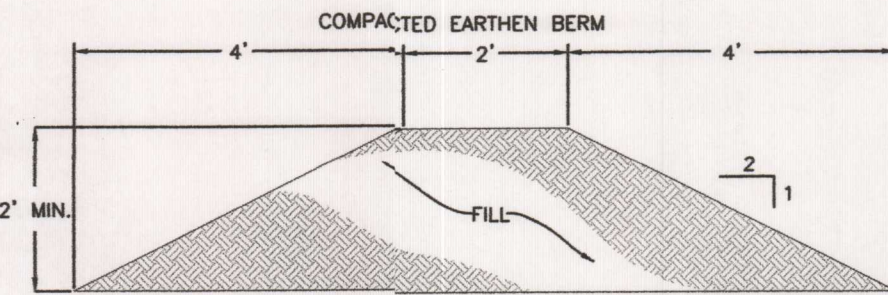
MAINTENANCE (TEMPORARY):  
INSPECT TEMPORARY BERMS ONCE A WEEK UNTIL SUFFICIENTLY VEGETATED. REPLACE AS NECESSARY.

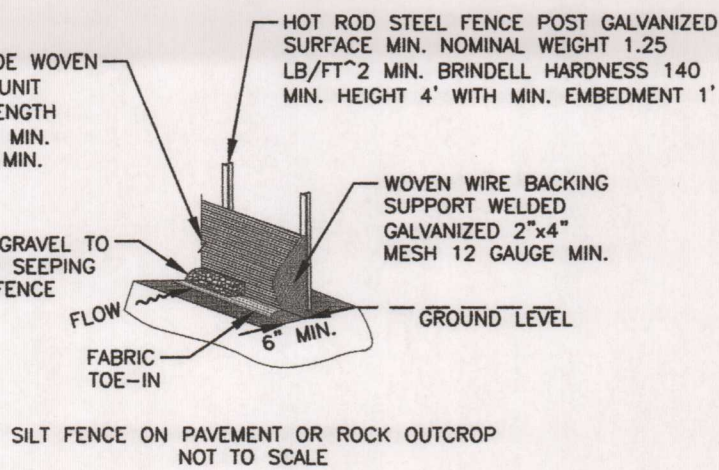
SILT FENCE ON PAVEMENT OR ROCK OUTCROP NOT TO SCALE

POLYPROPYLENE, POLYETHYLENE OR POLYAMIDE WOVEN OR NONWOVEN SILT FENCE WIDTH 36" MIN. UNIT WEIGHT 4.5 OZ/YD MIN. MULLEN BURST STRENGTH 190LB/N"2 MIN. ULTRAVIOLET STABILITY 70% MIN. APPARENT OPENING SIZE U.S. SIEVE NO. 30 MIN. HEIGHT 24" ABOVE EXIST. GROUND
